SCHIELE MUSEUM FOUNDATION REPAIR & MODIFICATIONS
Addendum #1

Reference: Report Of Geotechnical Engineering Services
Schiele Museum
1500 East Garrison Boulevard
Gastonia, North Carolina
Geoscience Project No. CH11.0047.GE

Geoscience Group, Inc. (Geoscience) has completed the soil test borings, laboratory testing and geotechnical analysis for the above referenced project. This work was performed in general accordance with Geoscience Proposal No. CH15.187P.GE. The purpose of this work was to obtain subsurface information and laboratory data in an effort to determine the logical cause(s) of the observed building distress. This report presents the results of our geotechnical engineering services and provides our general recommendations for the remedial repair.

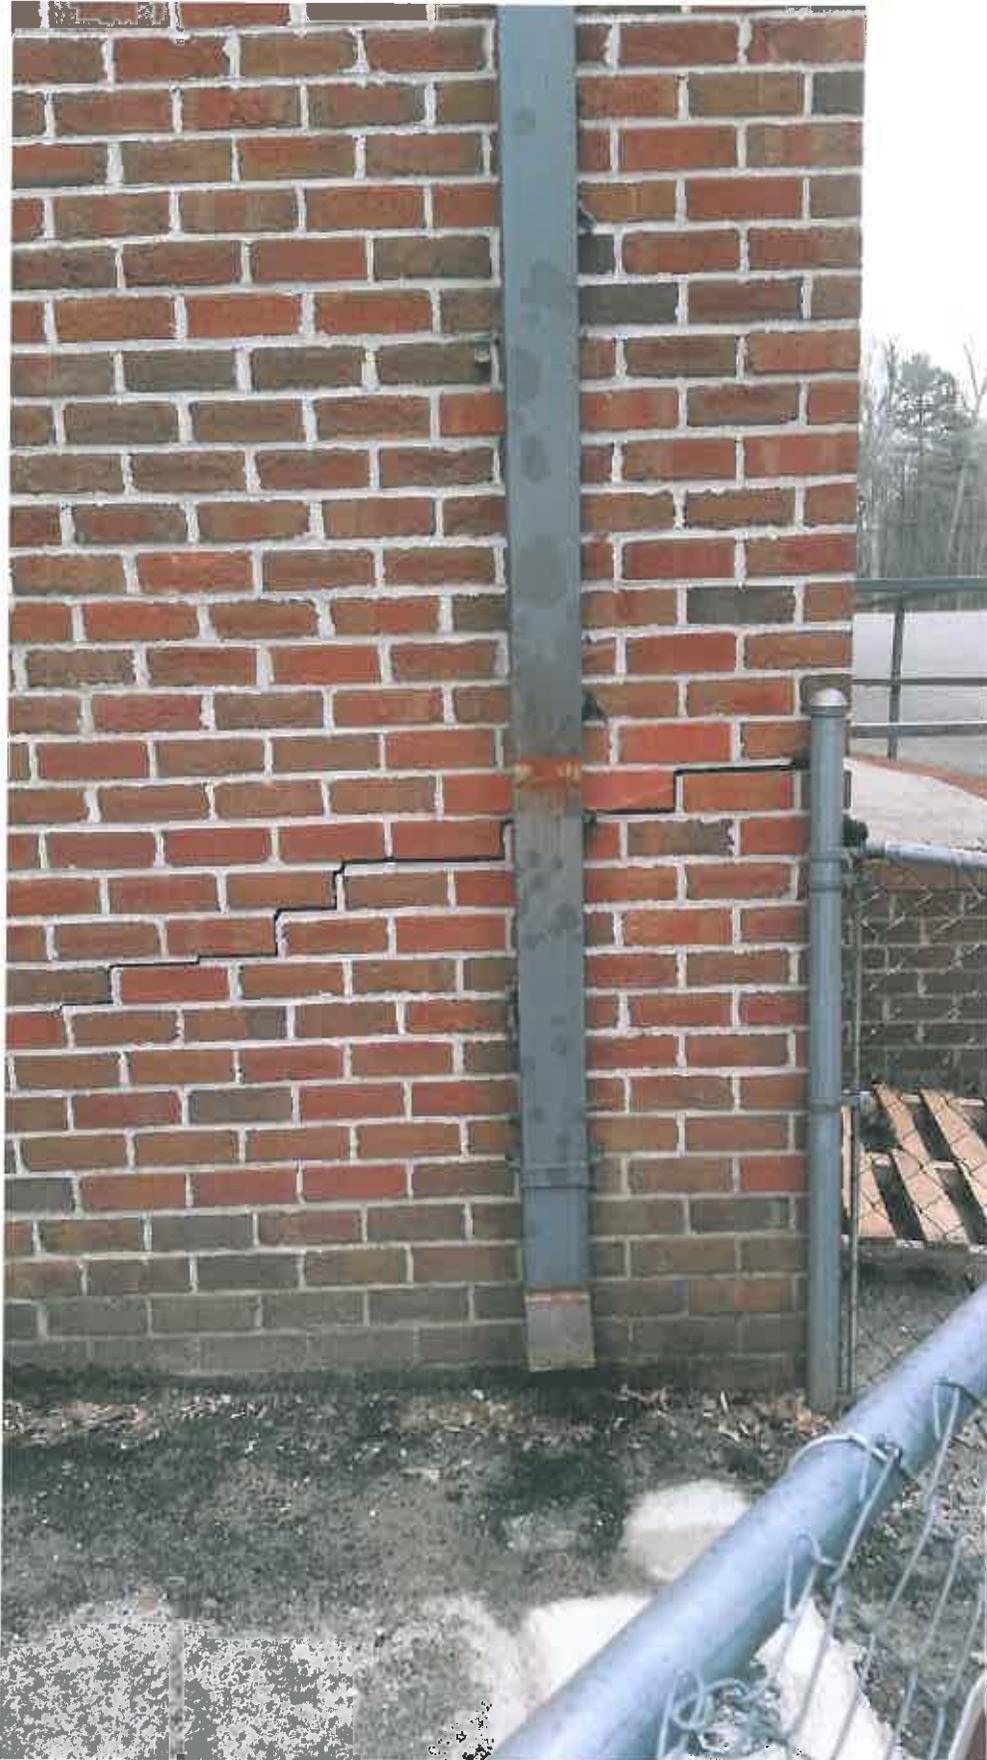
Photo 1: Crack In Exterior Wall – Robinson Hall Of Earth And Man

The results of the soil test borings indicate that up to 10½ feet of existing fill is present beneath the westernmost portion of the museum. The fill materials consist of a wide range of soil types that include silty CLAY, clayey SILT, sandy SILT and silty SAND soils. The Standard Penetration Test results (Blow Counts) within the fill soils were erratic and ranged between 1 and 95 Blows Per Foot (BPF). The majority of the Standard Penetration Test results are between 2 and 5 BPF. The erratic and low Blow Counts confirm the variability of the fill soil types and apparent lack of adequate compaction achieved during its placement. Improperly placed and softened fill soils will negatively impact structures that are constructed over this material. Therefore, some of the building settlement can be attributed to zones of poor quality and inadequately compacted fill that have consolidated beneath its own weight and the weight of the foundation loads.

We recommend that helical piers be installed along the exterior wall of the Robinson Hall Of Earth And Man Building. In addition, helical piers should be installed for the first 50 linear feet of the exterior walls for the adjoining office spaces. The approximate helical pier limits are shown on the *Proposed Foundation Repair Diagram*, Drawing No. CH11.0047.GE-4, included in the Appendix. These pier limits should be verified by the structural engineer and specialty foundation repair contractor. Helical pier capacities on the order of 30 to 40 kips could be achieved by extending the piers through the existing fill and residual soils to bear within the partially weathered rock beginning at depths ranging from approximately 7½ to 12 feet below the ground surface. The number of the helical piers and their spacing should be determined by the structural engineer. The helical pier installation should be performed by a qualified contractor and monitored to verify that the actual diameter, depth and torque of each helical pier are adequate to reach the design capacities.

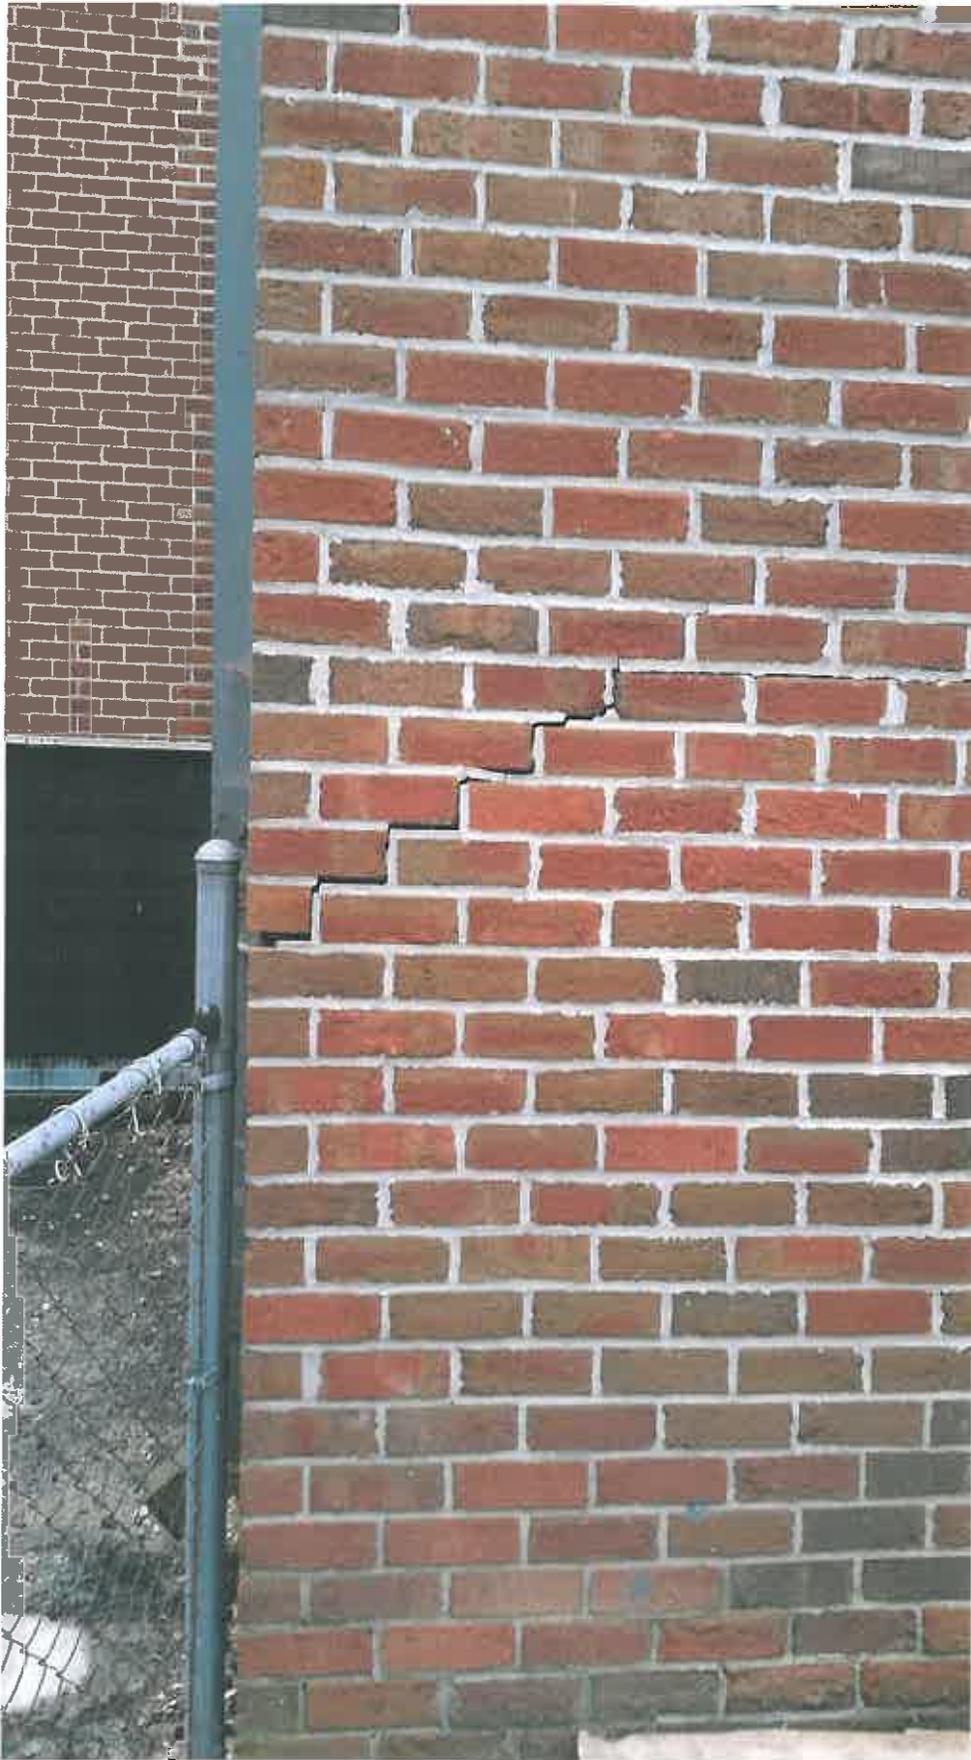
Photo 2: Crack In Exterior Wall – Robinson Hall Of Earth And Man

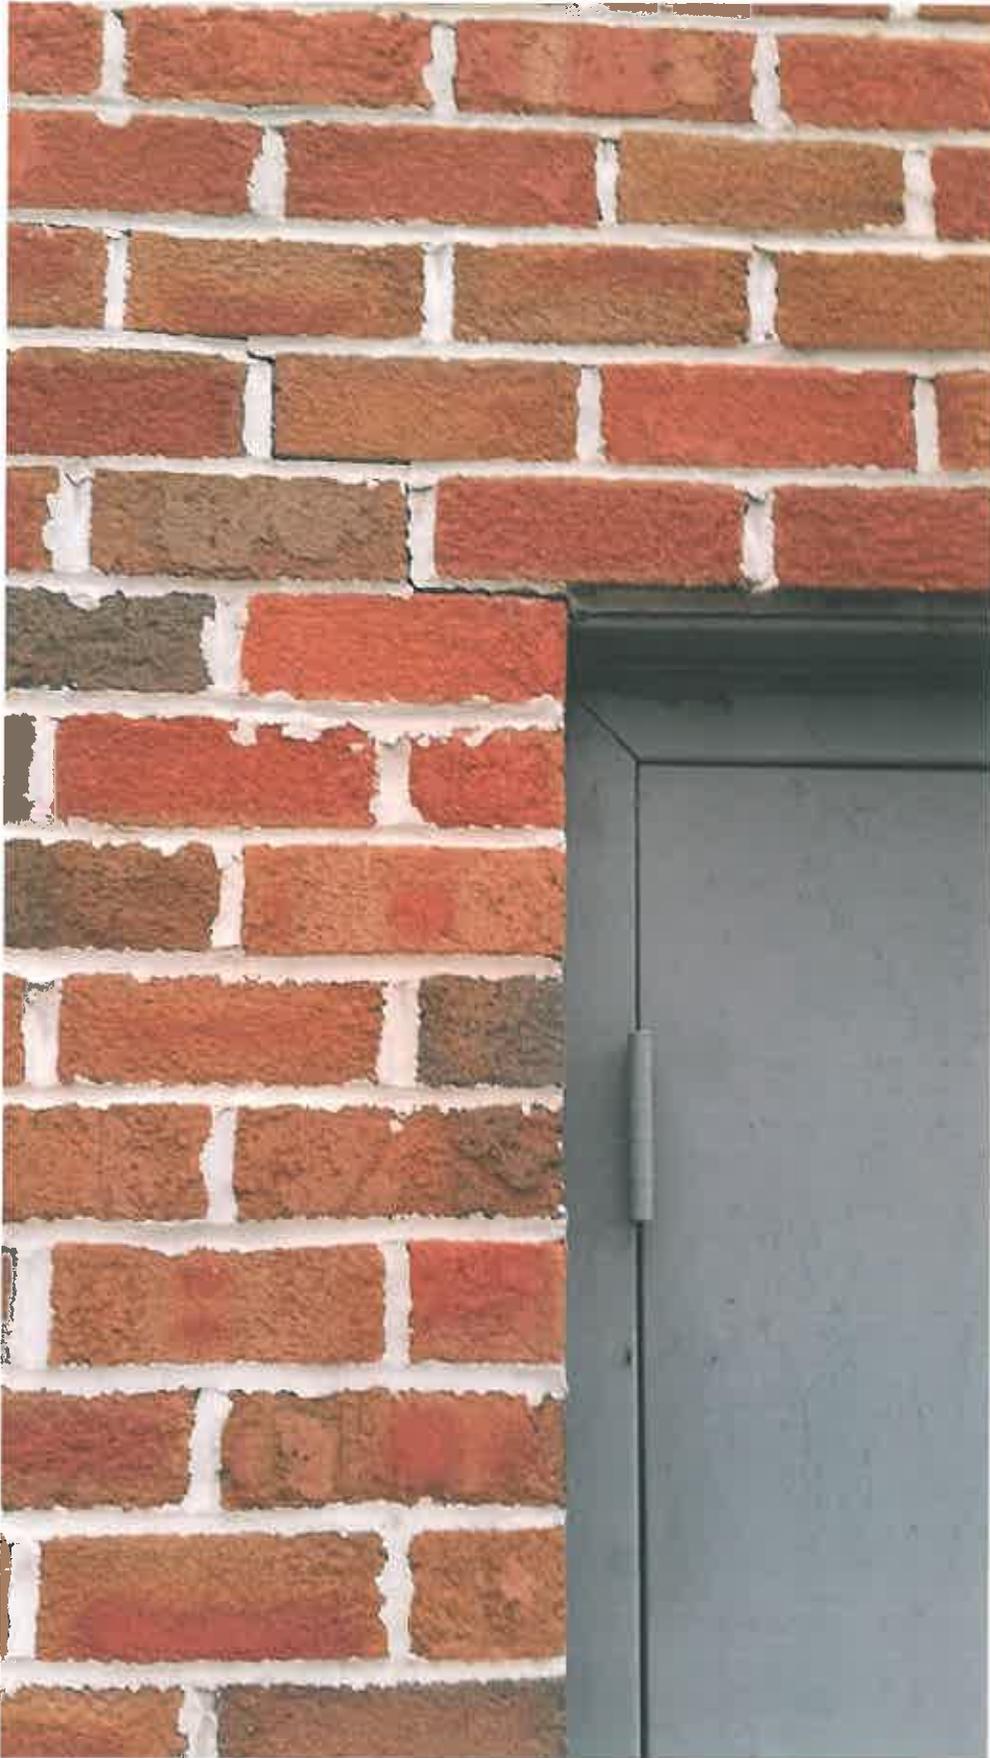
Photo 3: Crack In Exterior Wall Over Door Jamb – Robinson Hall Of Earth And Man

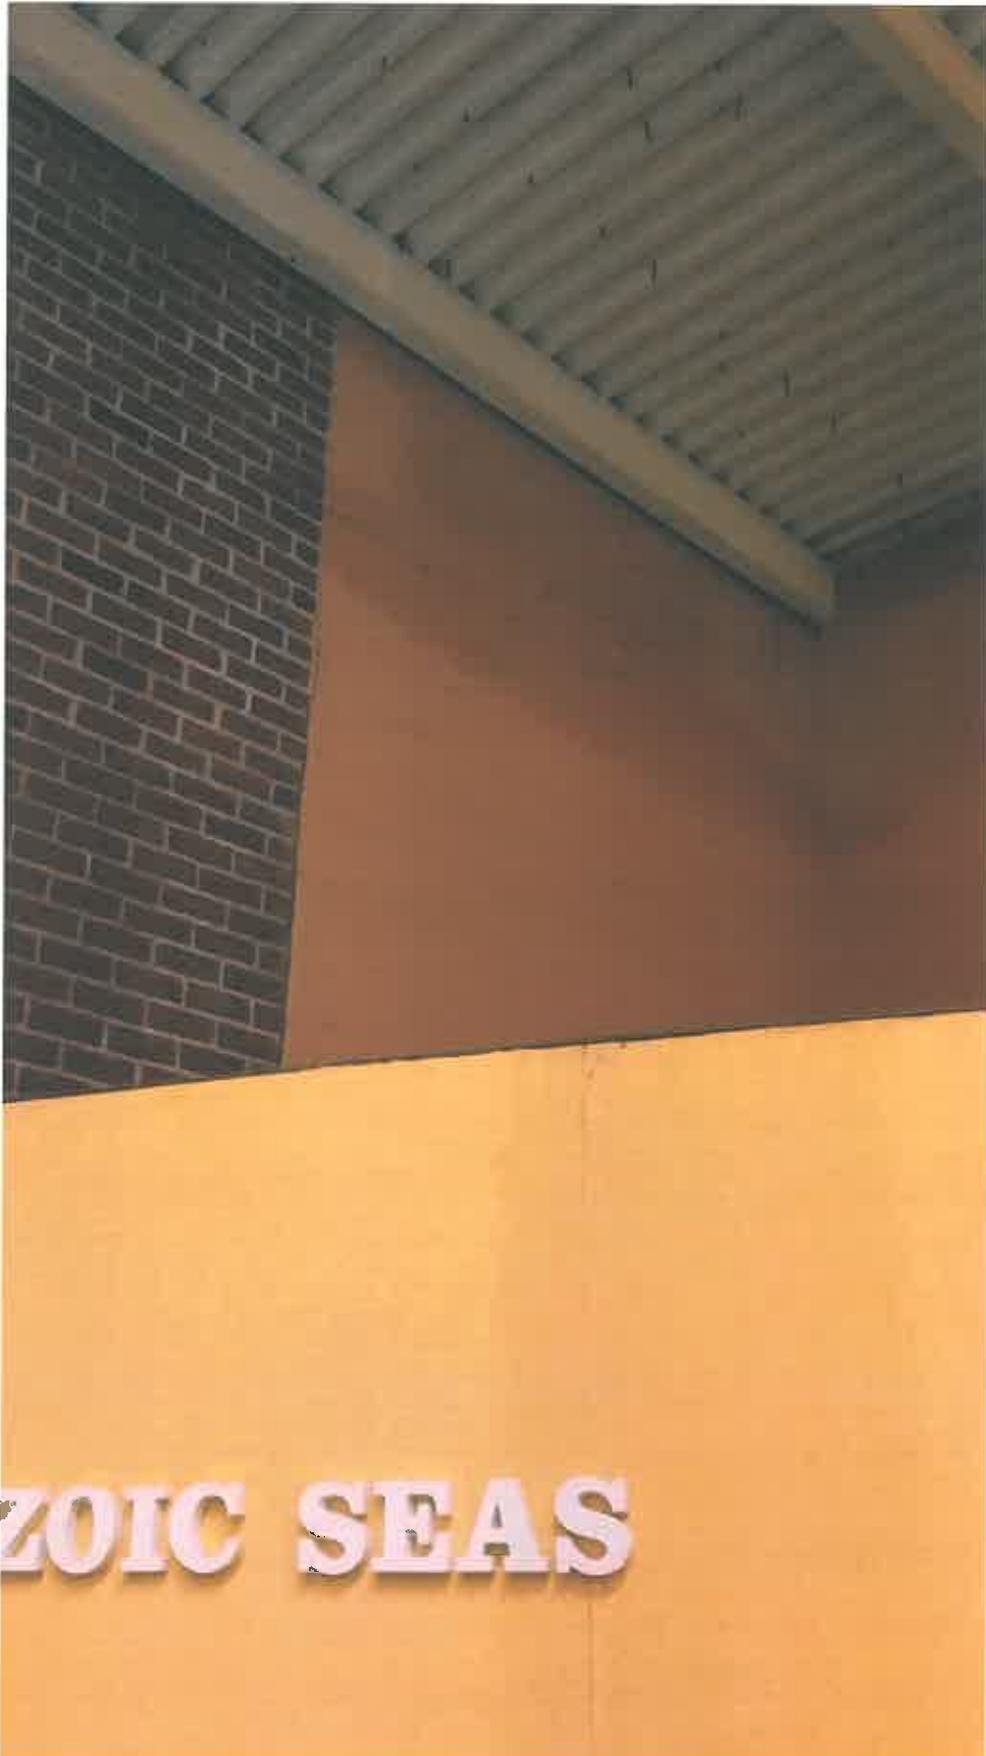
Photo 6: Crack In Shared Interior Wall – Hall Of North American Wildlife And Robinson Hall Of Earth And Man

We recommend that micropiles be installed along the interior east-west walls of the Robinson Hall Of Earth And Man Building. The approximate micropile limits are shown on the above referenced *Proposed Foundation Repair Diagram*. These micropile limits should be verified by the structural engineer and specialty foundation repair contractor. It is anticipated that 20 kip capacity micropiles can be achieved by extending the piles through the existing fill and residual soils to bear within the partially weathered rock. As with the helical piers above, the number of the micropiles and their spacing should be determined by the structural engineer. The micropile installation should be performed by a qualified contractor that can demonstrate the appropriate expertise with this type of remediation.
